**REHABILITATION OF THE SUROOR
ELEMENTARY SCHOOL
UNDER THE ECONOMIC SUPPORT FUND
HUSSEINIYA, IRAQ**

SUSTAINMENT ASSESSMENT

**SIGIR PA-08-135
APRIL 7, 2009**

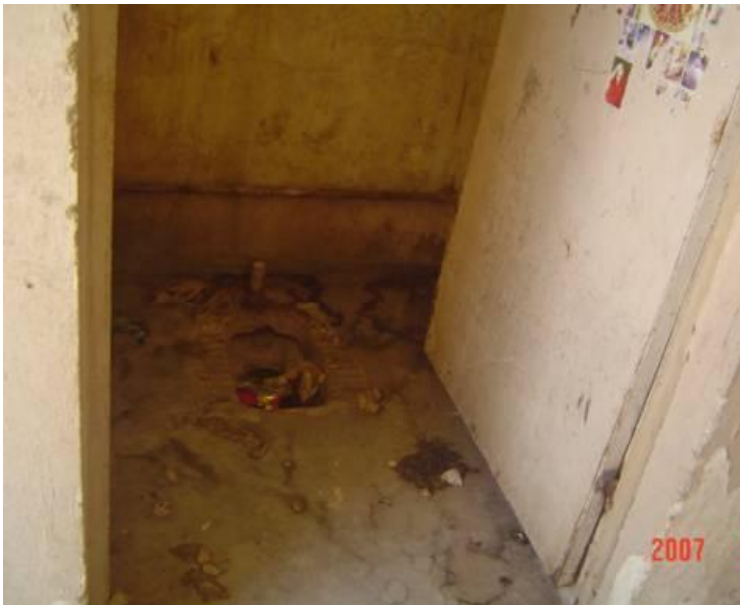
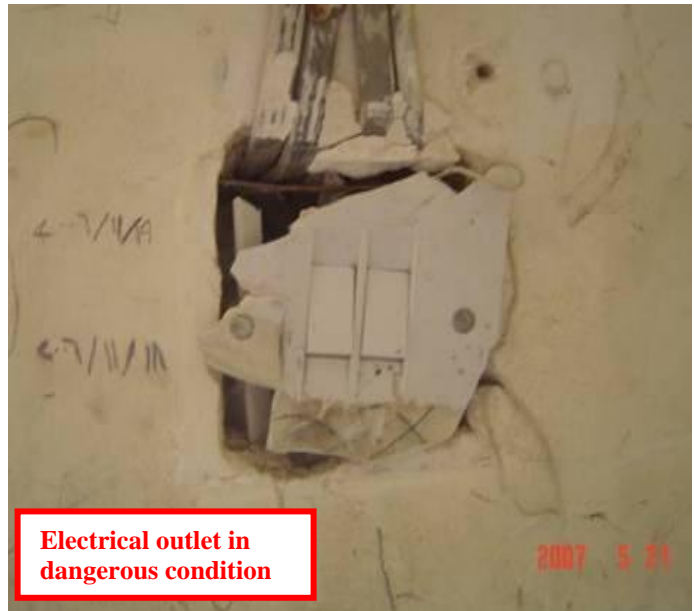
The school is located in the Husseinia village near Baghdad, Iraq. The school was in a state of major disrepair from years of neglect and failure to maintain adequate upkeep. Site Photos 1 and 2 document the poor condition of the school prior to renovation. The school's electrical system was unsafe, the plumbing system unusable, the restrooms unsanitary, and overall the school was unsafe.

Site Photos 1 and 2. Suroor Elementary School prior to renovation (Courtesy of GRC)

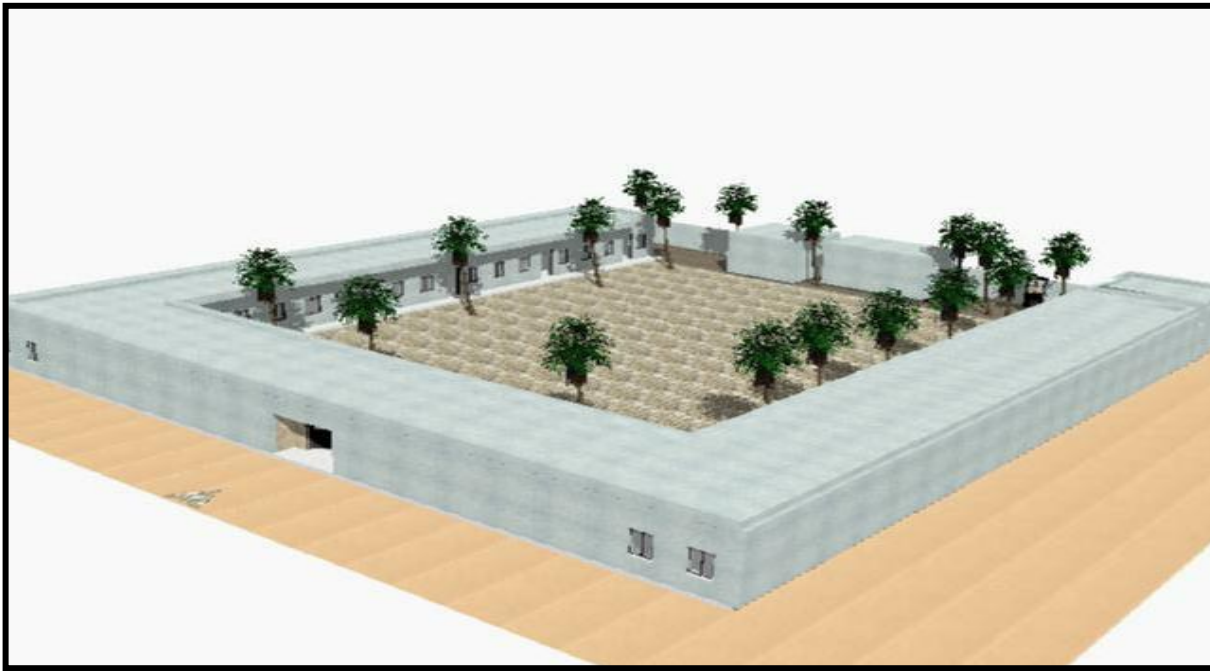
Figure 1. Illustration of the Suroor Elementary School after renovation (Courtesy of GRC)

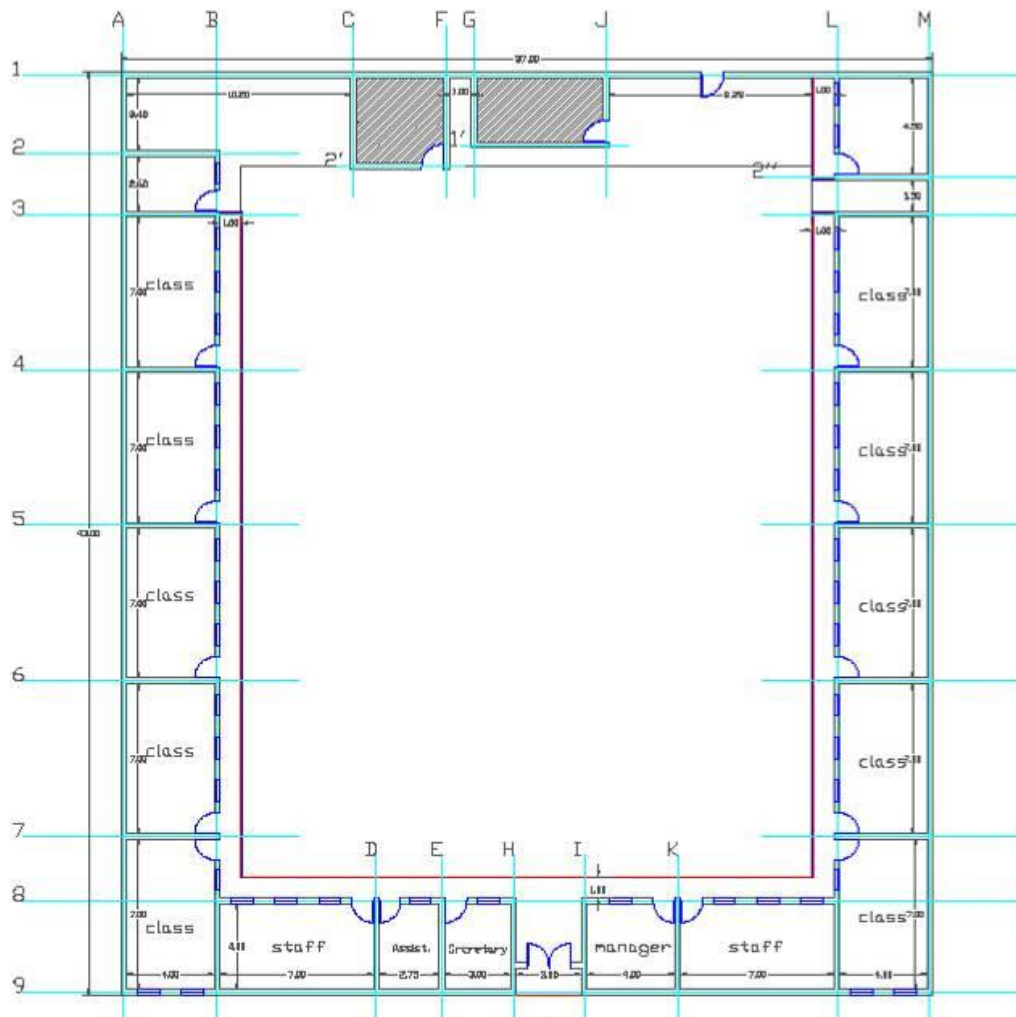
The architectural plans show the layout of 10 classrooms, 2 staff rooms, and administration areas (Figure 2). While the contractor's submittals included good details of the electrical distribution system, our review concluded that the design submittals did not appear adequate for the renovation project because of the omission of details such as elevations, plumbing, and storm drainage.

GRD disagreed and stated it was "appropriate for the contractor not to include storm drainage details in their submittal" since the SOW did not specifically address storm drainage or civil site work. However, this project included the replacement of colored tiles in the courtyard; therefore, civil site work designs were necessary and drainage for the courtyard needed to be addressed by the contractor in the design submittals.

Figure 2. Architectural layout of the school after renovation (Courtesy of GRC)

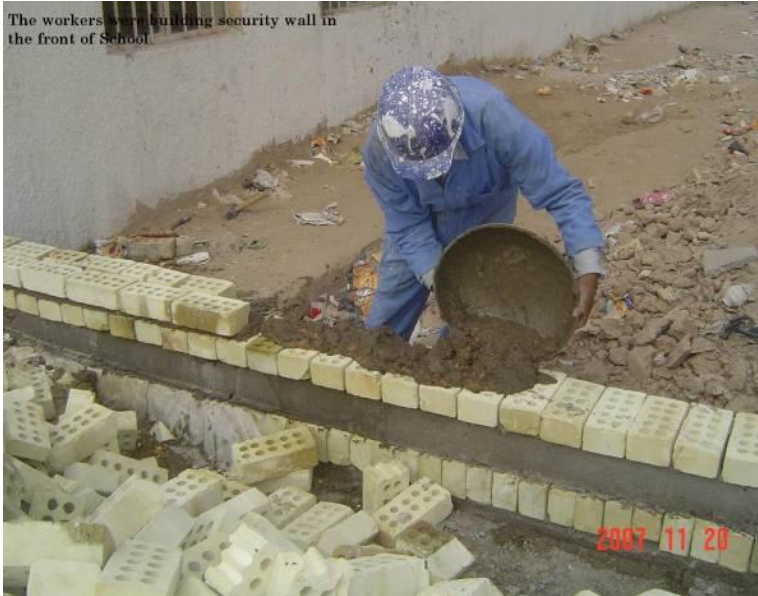
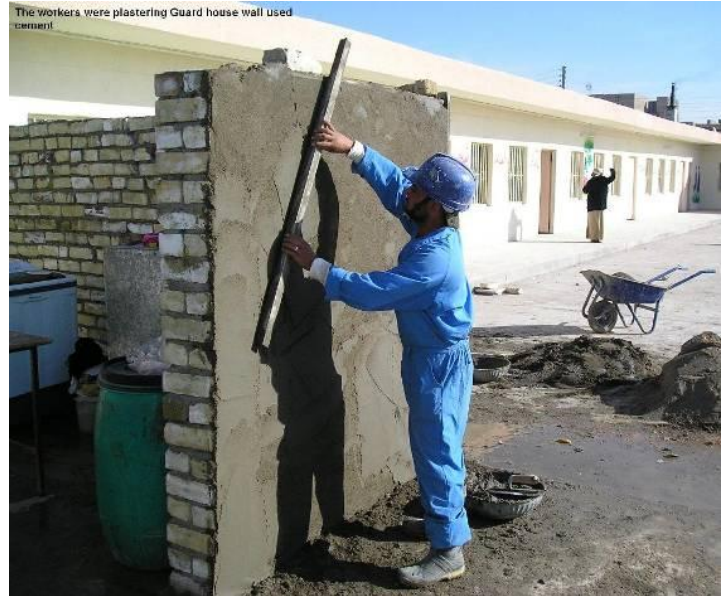
Site Photos 3 and 4 document the construction of the security wall and guard house wall, respectively.

Site Photos 3 and 4. Construction of the security wall and guard house wall (Courtesy of GRC)
